NASA TN D-1318

PERFORMANCE OF SEVERAL CAST NICKEL-BASE ALLOYS AS  
TURBOJET-ENGINE BUCKET MATERIALS AT 1650° F

By James R. Johnston, Charles A. Gyorgak,  
and John H. Sinclair

Lewis Research Center  
Cleveland, Ohio

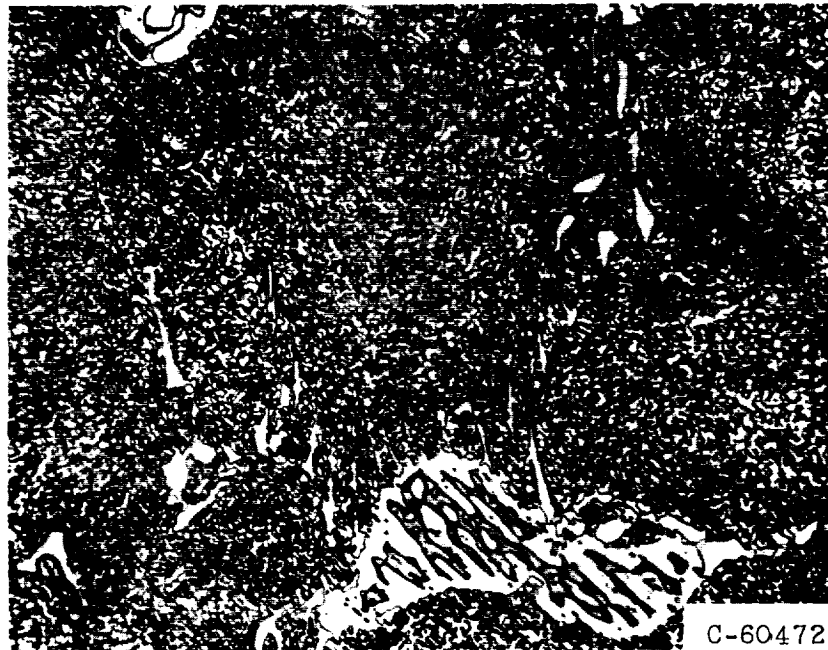
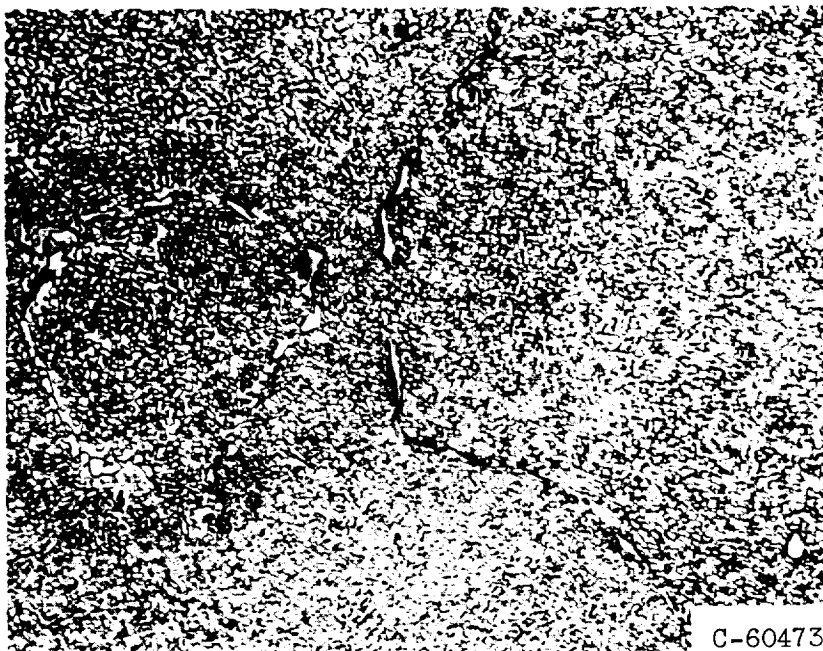
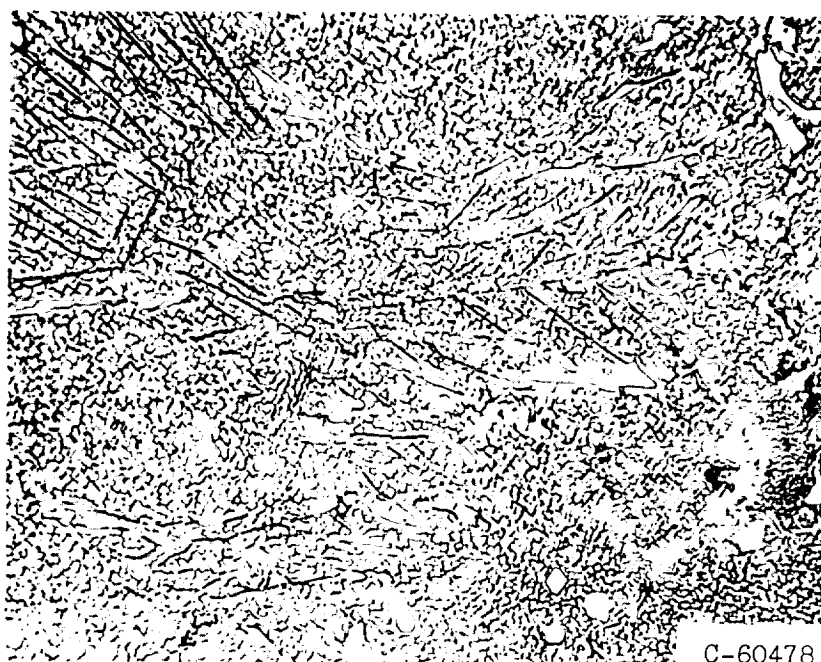
Figure 9. - Typical microstructures of engine-tested buckets.  
 Etchant: 20 parts glycerine, 20 parts  $H_2O$ , 10 parts  $HNO_3$ ,  
 5 parts  $HF$ .  $\times 750$ .

Figure 9. - Continued. Typical microstructures of engine-tested buckets. Etchant: 20 parts glycerine, 20 parts  $H_2O$ , 10 parts  $HNO_3$ , 5 parts  $HF$ .  $\times 750$ .

Engine tested buckets. - Typical microstructures of engine tested buckets are shown in figure 9. Comparison of the as-received and engine tested buckets of argon-cast Udimet 500, argon-cast Guy alloy, the NASA alloy, and Inconel 713 (figs. 8(a) to (d) and 9(a) to (d)) indicates no marked change in microstructure.

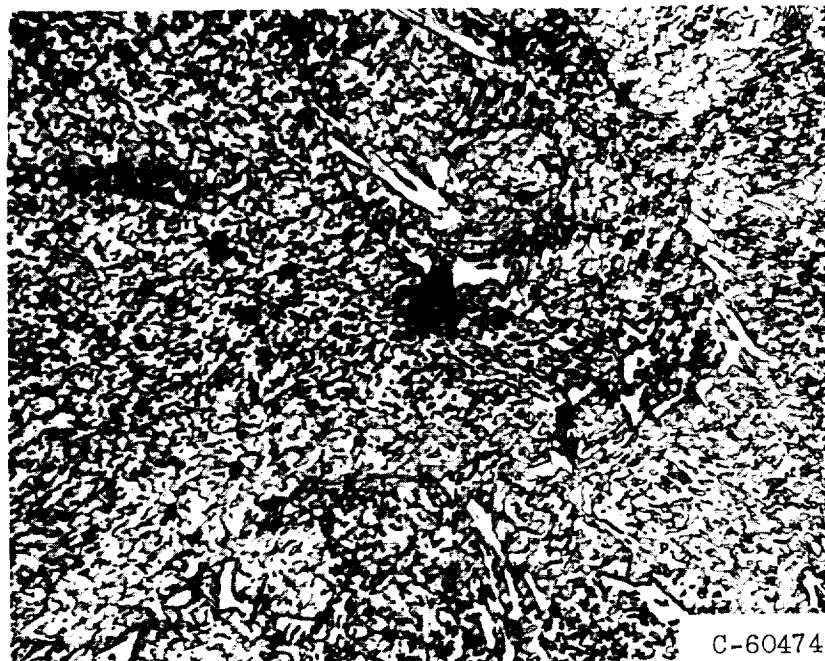
Figure 9. - Concluded. Typical microstructures of engine-tested buckets. Etchant: 20 parts glycerine, 20 parts  $H_2O$ , 10 parts  $HNO_3$ , 5 parts  $HF$ .  $\times 750$ .
